A NEW TECHNIQUE TO RAPIDLY IDENTIFY LOW LEVEL GATE OXIDE LEAKAGE IN FIELD EFFECT SEMICONDUCTORS USING A SCANNING ELECTRON MICROSCOPE.

Jim Colvin
Waferscale Integration Inc.
47280 Kato Rd.
Fremont, CA 94538

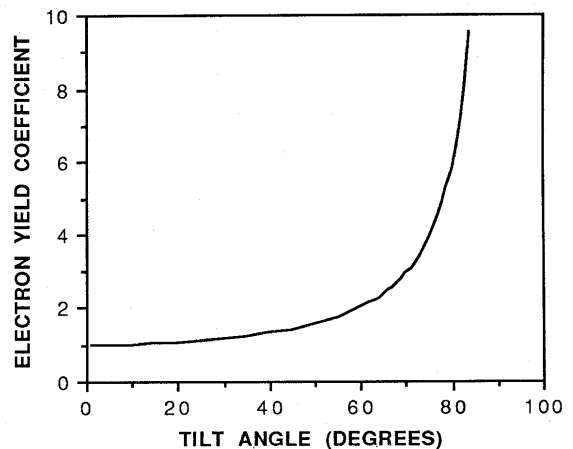
Figure 1. Inverse cosine function of electron yield vs. tilt angle.

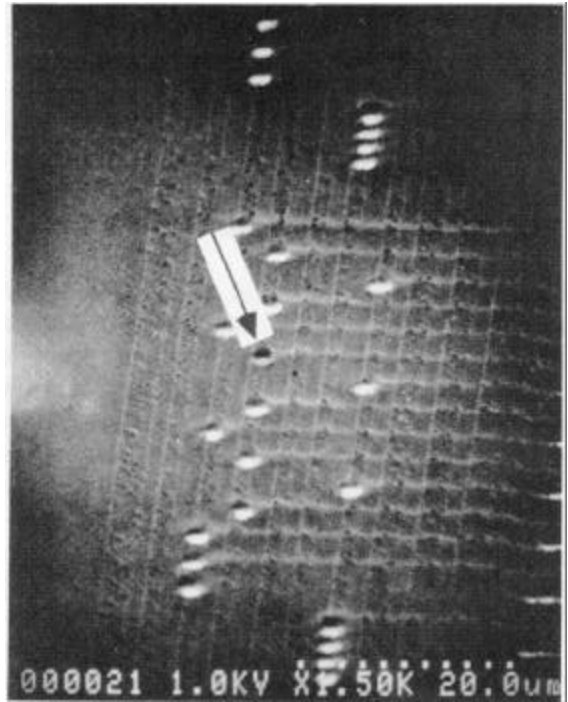
Figure 4. SEM micrograph of a series of uncharged floating control gates. A control gate in the center has been charged by concentrating the scan of the primary electron beam.

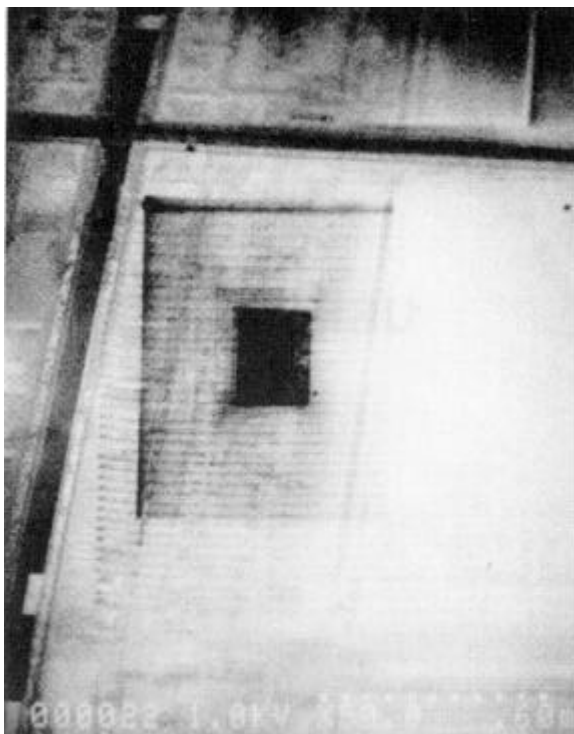
The part was opened with fuming nitric acid and examined. No defects were observed. Passivation was removed and the leakage isolated to the first inverter of the input by severing the metal line mechanically. Metal was then removed and the part examined in the SEM utilizing Passive Voltage Contrast. Figure 5 is a PVC image which identifies the failing p-channel gate responsible for the leakage. Note the illuminated contact.

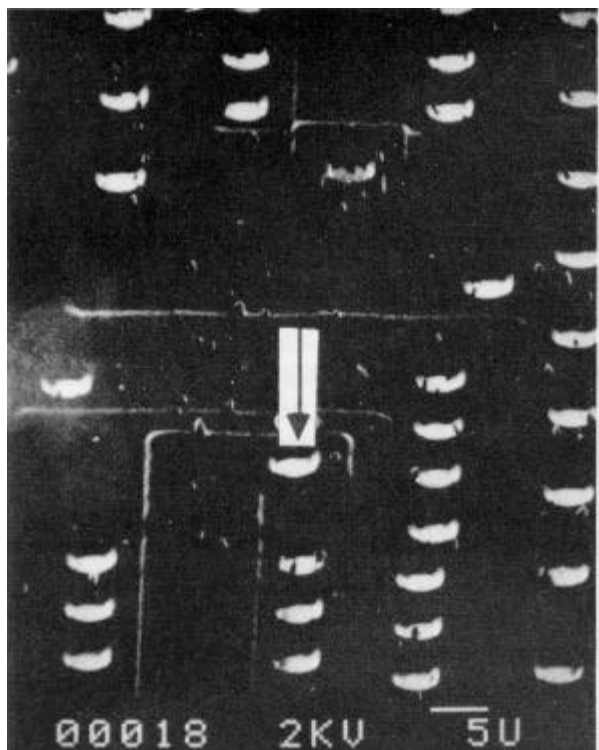
Figure 5. SEM micrograph of the defective p-channel transistor as identified by Passive Voltage Contrast (center). The n-channel device (above) is normal.

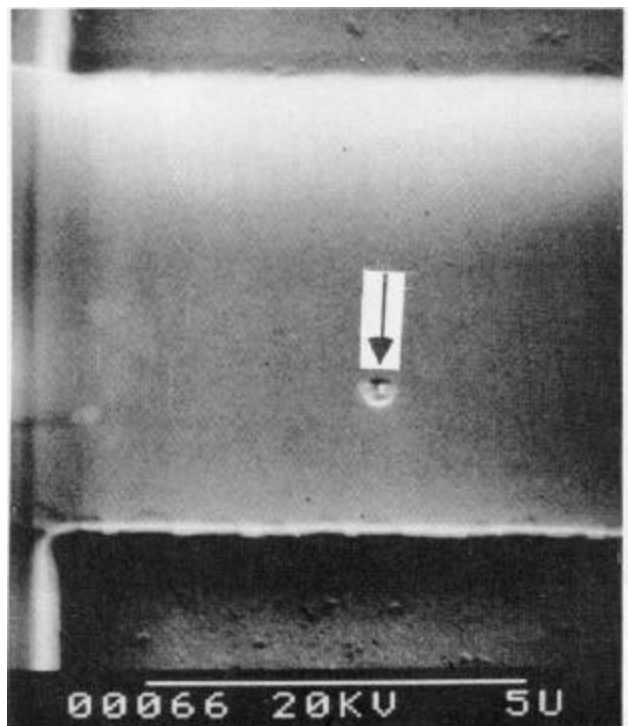
Figure 6. SEM micrograph of the oxide integrity defect responsible for the 50 nA of input leakage.

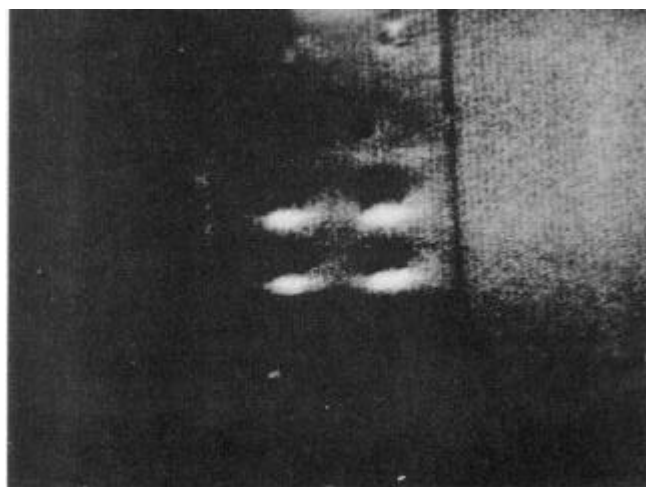
Figure 7. SEM micrograph of the illuminated contacts associated with a defective PCM gate.

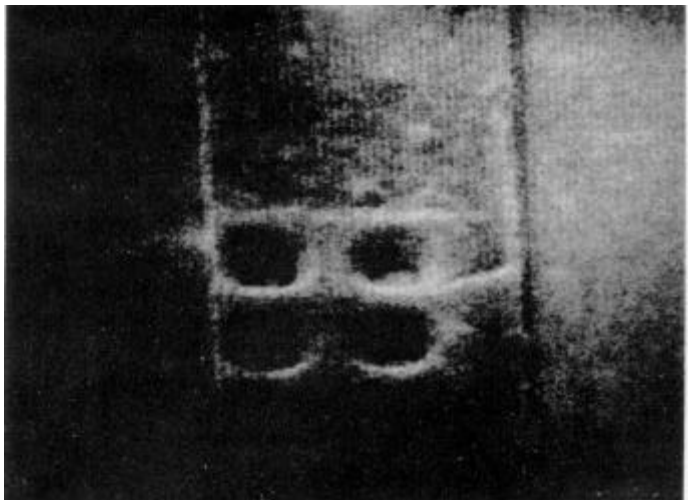
Figure 8. SEM micrograph of an adjacent normal PCM gate as determined by PVC.

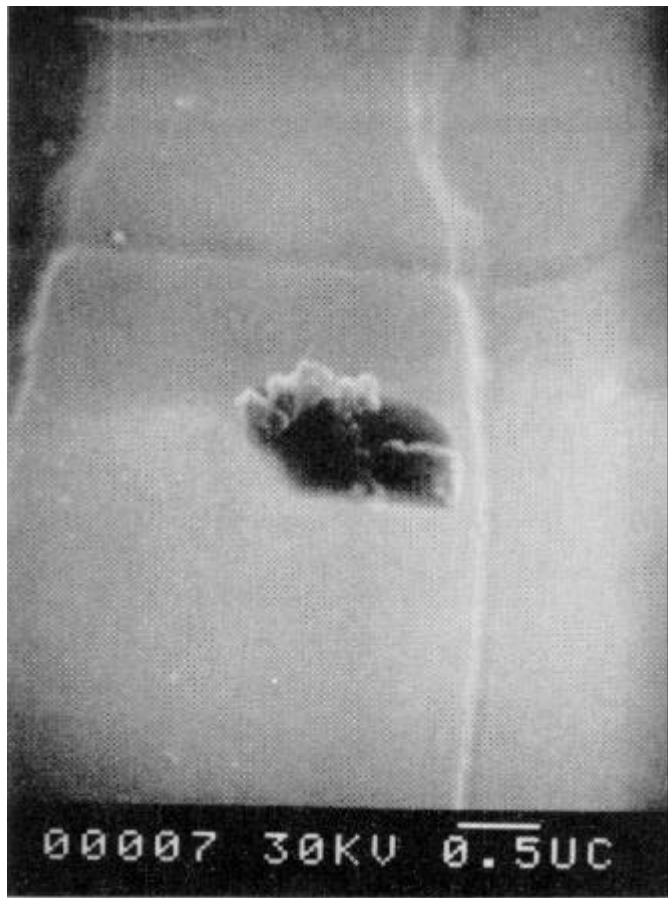
Figure 9. SEM micrograph of the gate oxide defect responsible for the short.
